Flooding In Darien

March 2, 2007

- Short Intense Event:
approx. 3.5-4" rain over
4 hours
- Frozen Ground
- Some snow cover
- All watercourses
flooded
- Homes evacuated
- Lives & commerce
disrupted

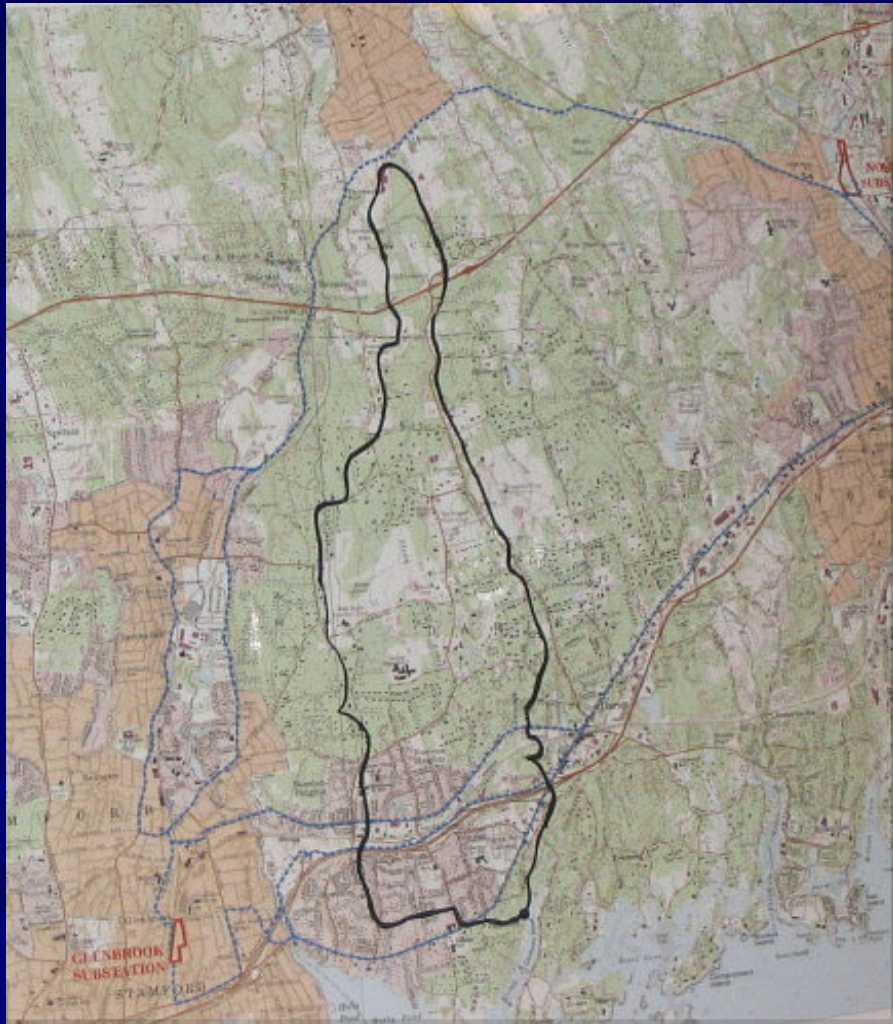
Stony Brook Characteristics

- **Drains approx. 40% of Town**
3.91 sq. mi.
2,502 acres
- **Sixty years of flooding**
- **Frequently floods**
- **Rapid increase in water surface elevation**
- **Mostly private property**

- Channel Improvements along the majority of the brook from Gorham's Pond to RR.
- Culvert replacements at Relihan Road, Town Hall (done) and Maple Street.
- Bridge replacements at Renshaw Road, Noroton Ave (done) and Post Road (done)
- All improvements should be done from Gorham's Pond working upstream.
